V. DESCRIPTION OF SURVEYED PROPERTIES

CLIENT Delaware Department of Transportation		TITLE HISTORIC PROPERTY SURVEY MAP WEST END
PROJ Carter Road Improvement Study		
REVISION NO		
SCALE NOT TO SCALE		
FILE NAME P:\D8-000001\12.08\Smyma\Aerial North		
PROJ NO D8-000001\12.08 00D01		FIGURE
		11

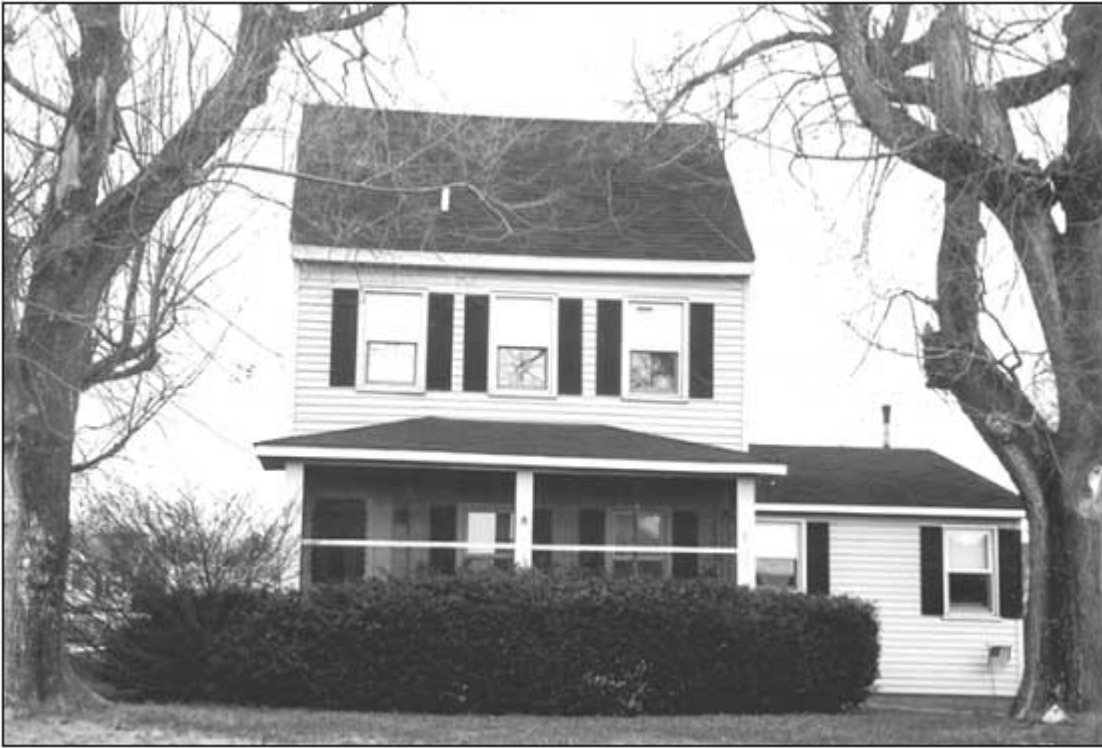
Figure 14 – K-3867 House 102 S. Carter Road

The house is a circa 1870-80 2½-story Folk Victorian-style story dwelling located at the northeast corner of Carter Road and South Street (Figure 14). It has a side gable form with a rear two-story ell and a side addition of one story. The frame structure is presently sheathed with vinyl siding. Windows are 1/1-vinyl sashes, which are also recent replacements. The hipped roof porch has been screened in.

A one-story gable front shop sits to the rear of the property facing South Street. This building appears to date to circa 1955 and is constructed of concrete block masonry with a small frame addition on the east or rear façade. Vinyl siding covers the gable ends below the roof. Two large single-pane windows with projecting brick sills flank the central door. This building was used by the owners as a screen repair shop and prior to that it operated as a television repair shop. In 1988, the lot was subdivided so that the shop now stands on a separate lot under different ownership than the house.

Through the addition of two wings and the replacement of windows and siding, this house has lost much of its historic integrity. To be considered eligible for the National Register, it is important that the property retain important character-defining features of a late twentieth century vernacular residence, and that these features not be obscured by later alterations. The property's character-defining exterior materials, including original or historic wooden siding, ornamental details and original or historic windows have been either replaced or removed. The addition of two wings are unsympathetic to the historic design and were constructed after the property's period of significance. As a result, the property does not sufficiently convey its historic design or appearance.

The replacement of historic wood siding with unsympathetic tan vinyl siding (in addition to the replacement of original windows) has obscured an important, character-defining feature and craftsmanship of this property. Although it maintains its original form and symmetrical façade characteristic of the property type, it lacks the distinctive spindlework or flat jig-saw cut trim frequently found in this property type. The property does not possess distinctive characteristics of a property type, is not identified with the work of a master, nor is part of a district of like resources. Thus, this building is not a distinct or particularly representative example of its type or style of architecture and is not considered eligible under Criterion C.

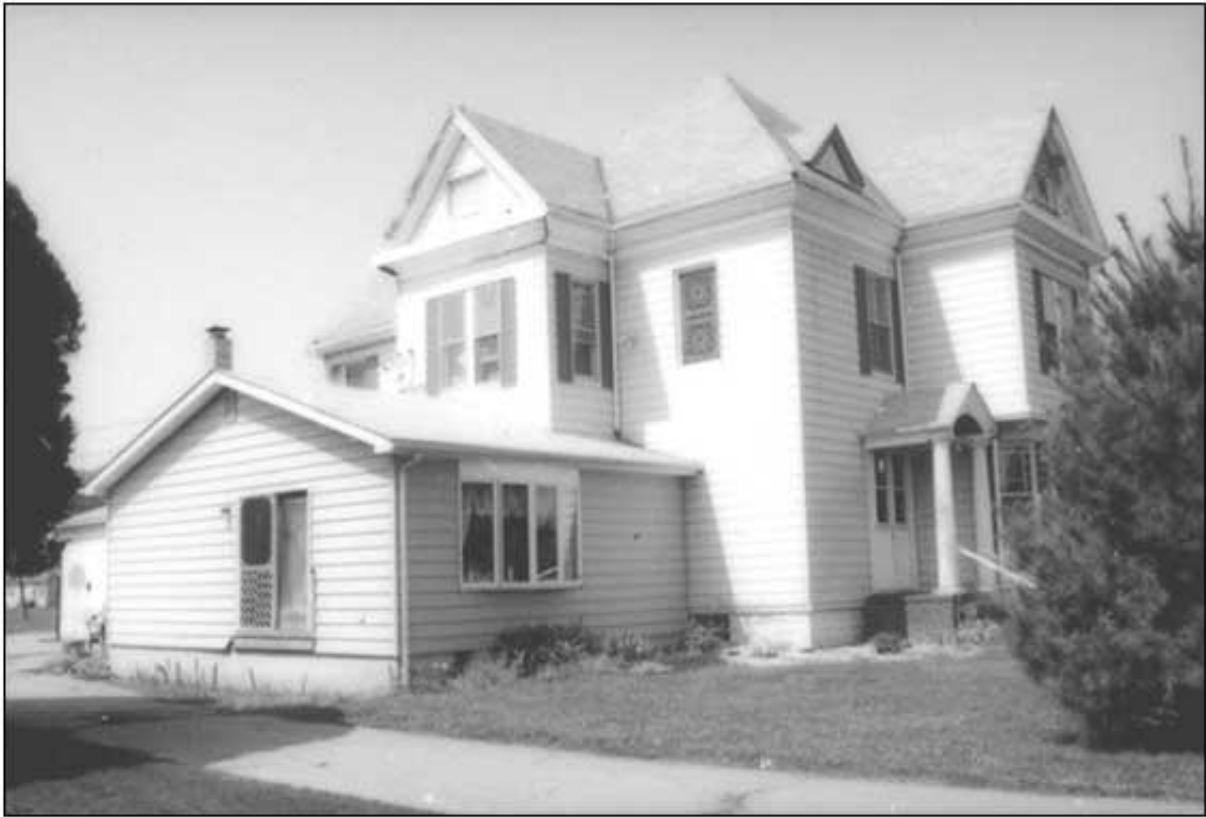
Figure 15 – K-3870 House 101 N. Carter

The house is frame with vinyl siding and asphalt shingles covering the complex intersecting hip and gable roof (Figures 15 and 16). Many of the original windows remain in place. On the first floor, these are 1/1 wood sashes with 12 small colored panes surrounding the top sash. The second-floor windows contain 1/1 and 2/2 wood sashes. The attic contains a fixed decorative window in the front gable with multi-colored lights surrounding a single pane. The rear gable contains a pair of 6/6 wood sash windows. In the rear additions, non-historic louvered windows are present. Basement windows are 6-pane hopper sashes.

Alterations to the building fabric, including several unsympathetic additions in the rear and the replacement of siding, have affected this dwelling’s historic integrity. The use of modern vinyl siding obscures important ornamental details (which reveal original craftsmanship) on the property’s exterior, and inhibits the property’s ability to convey important historic information. As a result of material replacement, this house has lost much of its historic integrity. In addition, additions, including a porch enclosure, are unsympathetic to the historic scales and design of the property. To be considered eligible for the National Register, it is important that the property retain important character-defining features of a late nineteenth-century Queen-Anne residence, and that these features not be obscured by later alterations. The property’s character-defining exterior materials, including original or historic wooden siding, ornamental details typical of the Queen Anne style have been either replaced or removed. Although similar vernacular Queen Anne residences display a broad range of architectural elements, this particular example lacks several important key features of the property type. For example, detailing devices such as shingles used to avoid flat surfaces have either been removed or covered. The building also lacks an elaborate porch. The property does not possess distinctive characteristics of a property type, is not identified with the work of a master, nor is part of a district of like resources. Thus, this building is not a distinct or particularly representative example of its type or style of architecture and is not considered eligible under Criterion C.

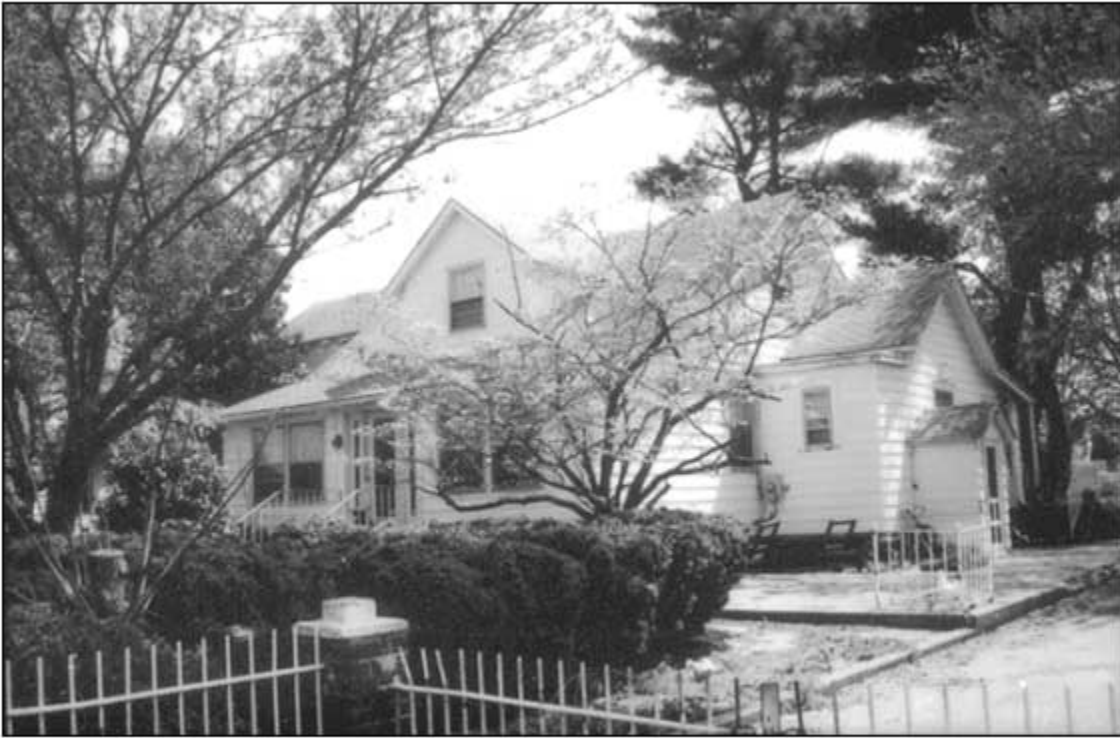
Figure 17 – K 3898 House Wheatley's Pond Road

This circa 1926 house faces northwest toward Wheatley's Pond Road, just southwest of its intersection with Route 6 (Figure 17). It is a 1½-story frame bungalow cottage with weatherboard siding and 8/8 vinyl windows on the main façade and primarily 6/6 wood sash windows on the rear. The front porch has been enclosed and a side addition on the southwest side, and a rear addition on the southeast side have altered the overall form of the house. Since the 1981 survey, the Craftsman-style front door has been replaced with a vinyl-clad single-pane door, which is flanked by single-pane sidelights.

The building is not a representative example of the Craftsman-inspired residential design of the period. A predominant character-defining feature of the building type is a wide, deep open front porch; however, the enclosure of the porch on this house has compromised this critical design element. The enclosure has obscured anchor pillars (if they were originally present) and the building lacks broad, overhanging eaves, both of which are also character-defining features. Thus, the property does not possess distinctive characteristics of the property type, is not identified with the work of a master, nor is part of a district of like resources. Because of the lack of significant architectural style, materials, form, or details, this house is not considered eligible for listing in the National Register under Criterion C.

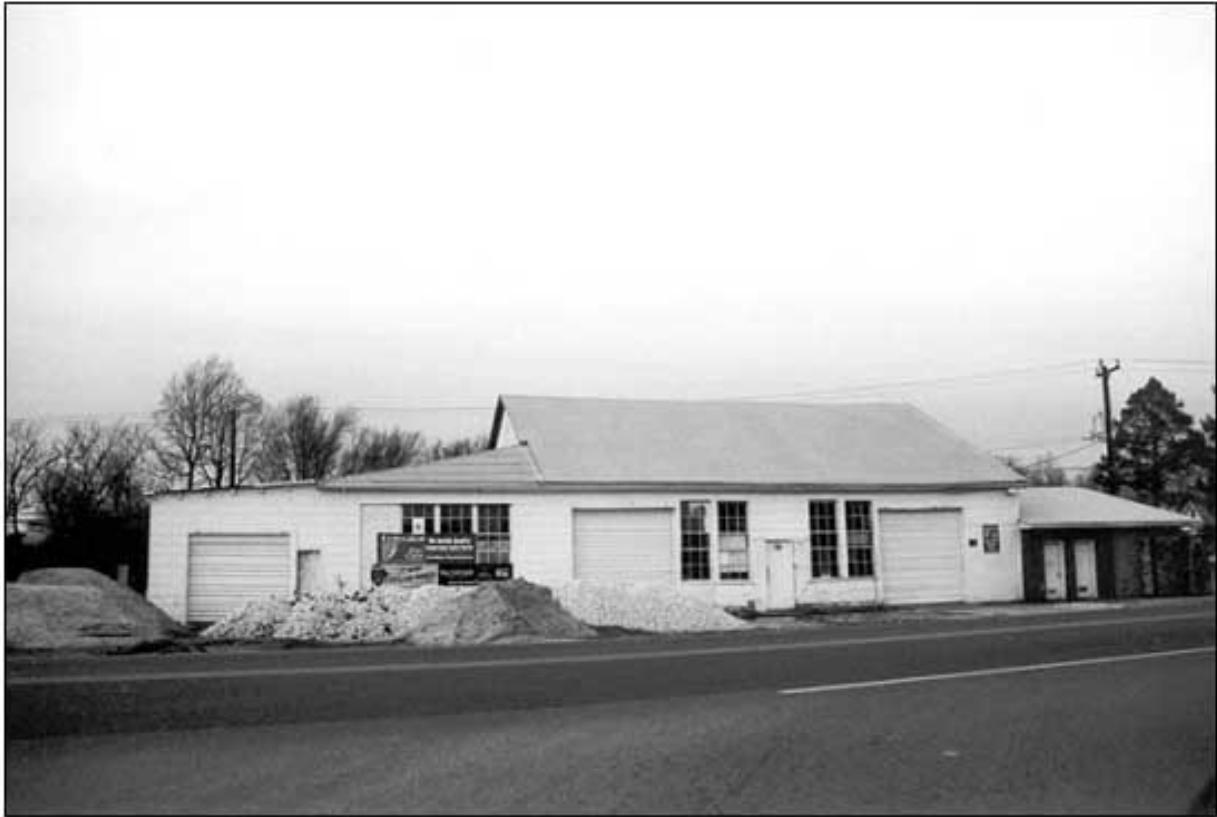
Figure 19 – K 7061 L & R Mini

This large gas station/convenience store was built circa 1925 as a car dealership. It faces north on a triangular lot at the intersection of Wheatley's Pond Road and Route 6. The building consists of a 1½ story gable roof center portion with a historic hipped roof shed to the south and a modern hipped roof addition to the north, each one story in height (Figure 19). It has an ornamental rough-faced concrete block foundation and was originally sided with clapboard, which has been covered with asbestos shingles. The window frames are metal with a 9/6 pane configuration and a pivoting lower sash. Some are paired and several have been covered over with plywood or infilled with concrete block, particularly on the west façade, where all windows have been infilled. A brick chimney is attached to the west façade.

The south addition is frame with asbestos shingle siding and a concrete block foundation. Exposed rafter tails project from under the roofline of the hipped roof. Garage doors open from the east and west sides. All windows on the south façade have been covered over. A brick chimney is attached to the south façade.

The north addition, added circa 1970-75, is one story in height with a front gable roof. It is sheathed in brick veneer and contains the L&R mini-mart. Large paired single-pane windows flank the central modern door. Side windows are 2/2 horizontal sashes.

Other alterations have also compromised the architectural integrity of this building. In addition to removing any free-standing or attached signs and covering over the windows, this building has replacement siding, additions at either end, and is no longer in use as a gas station. Although it is an early example of an automobile-related building in the Smyrna-Clayton area, the integrity of this property has been compromised to the point that its original and historic uses are hidden. Little information remains in terms of materials and form to relay the fact that building was used as a car dealer and service station. Because of these alterations and the difficulty they pose in relaying this building's history, the Pleasanton's Garage/Wheatley's Service Station building is not considered eligible for the National Register.

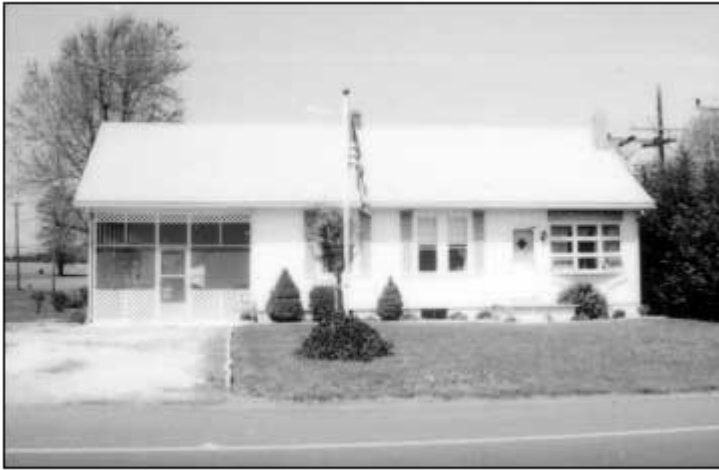
Figure 20 K-7062 5205 Wheatleys Pond

The side-gable cottage residence dates to circa 1950 (Figure 20). It appears to be constructed of cinder blocks, which have a stucco facing. The foundation is also cinder block and the roof is covered with asphalt shingles. The windows are 8/8 and 6/6 vinyl sashes. The off-center door is modern with a diamond-shaped cutout. To the northeast of the door, a bowed bay projects with three louvered vinyl windows. A screened side porch was integrated into the original construction. A central brick chimney punctuates the roof. Two non-historic shed are located to the rear (northwest) of this dwelling.

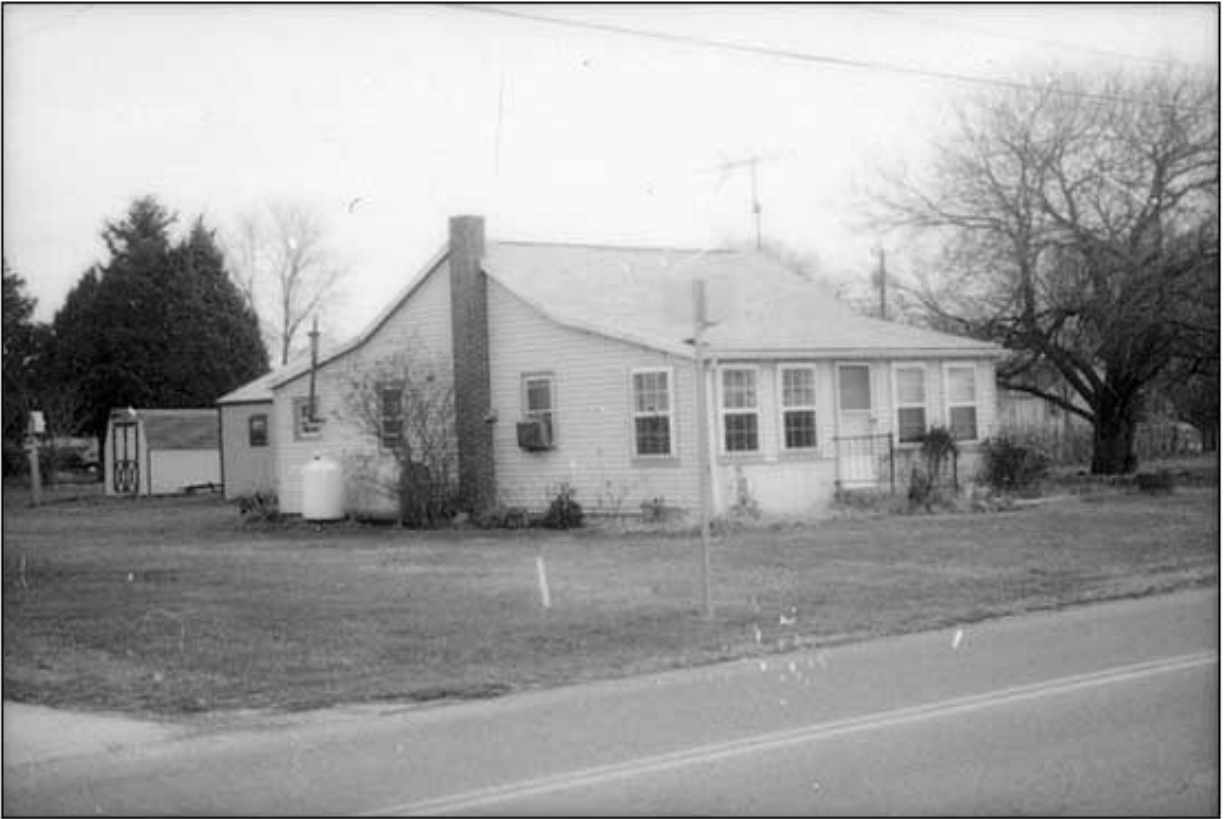
Figure 21-K 7063 48 S Carter

The small dwelling at 48 S. Carter Road is located on the northeast corner of the intersection of Carter Road and Cummins Street. It is a circa 1930 one-story frame house with side-gable roof, which encompasses an enclosed front porch (Figure 21). The house rests on a concrete foundation and is sheathed with aluminum siding. Windows are 6/6 vinyl sashes and an exterior concrete block chimney is attached to the west side. The driveway leads to a modern frame and aluminum garage.

This house has been significantly altered. The siding and windows have all been replaced and the front porch has been enclosed, greatly modifying the original appearance of the main façade.

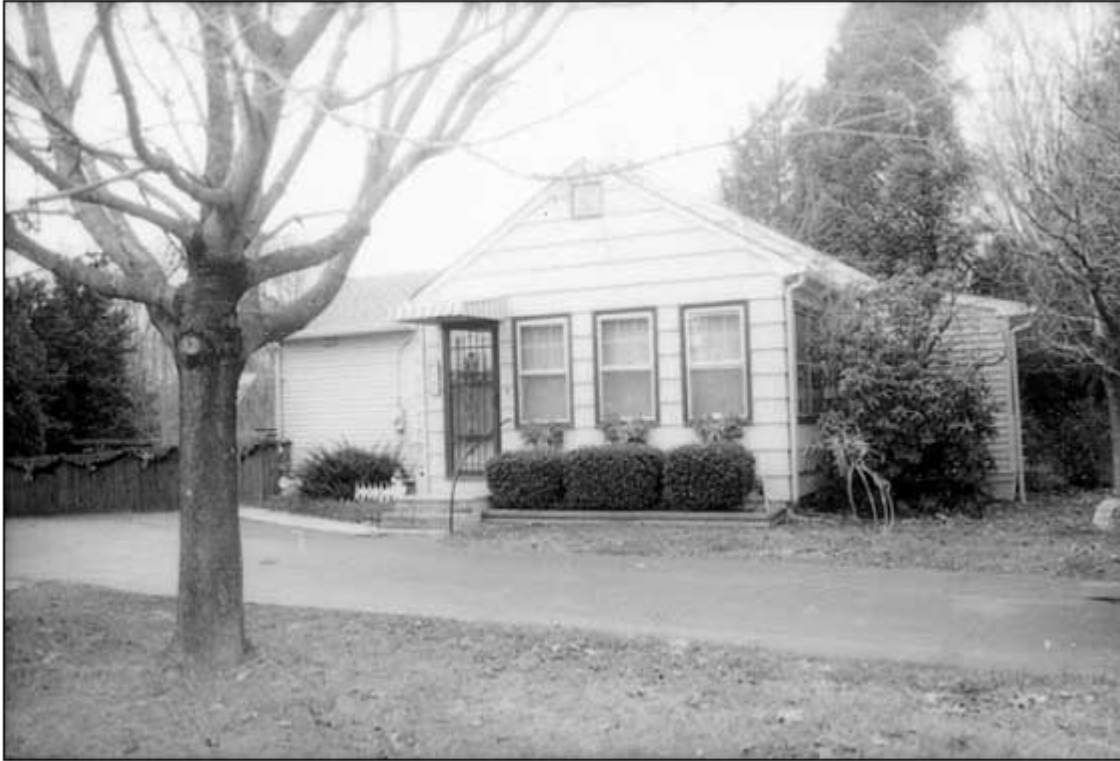
Figure 22 K-7066 549 S. Carter

This small front-gable cottage dwelling faces east toward the intersection of Carter Road and Sunnyside Road, and dates to circa 1935-40 (Figure 22). It stands one story in height above a concrete block foundation. The intersecting gable roof is sheathed with composition shingles. The walls are sheathed with asbestos shingles on the east façade and vinyl siding on the north and west. The primary (east) façade contains three 6/1 wood sash windows and a six-light over four-panel historic door under a modern aluminum shed. A small shed roof addition with 2/2

vinyl windows was added to the north façade. The central chimney has been replaced with a metal pipe vent. A non-historic two-car garage is located off the southeast corner of the house.

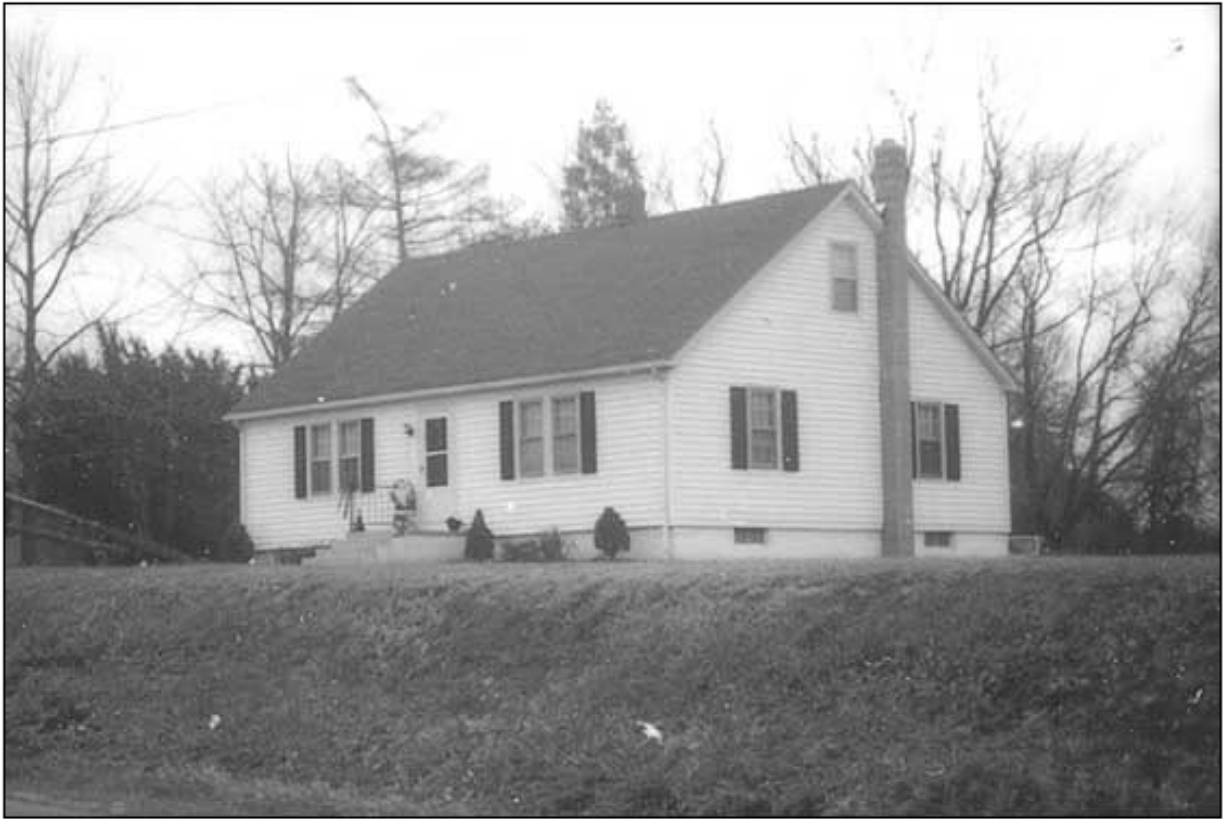
Figure 23
K 7064 423 S. Carter

This house is located on the south side of Carter Road between South Street and Manor Drive. Built circa 1948, it is a typical post-World War II cottage (Figure 23). It has a side-gable roof and symmetrical façade with a central door flanked by paired 6/6 windows. Windows on all facades continue the 6/6 configuration; all have modern black shutters. The house rests on a concrete block foundation and has been sheathed with vinyl siding. There is a central interior

brick chimney and an exterior-end concrete block chimney on the west façade. The stoop is concrete with no porch roof. A stoop on the east façade leads into a door off the driveway.

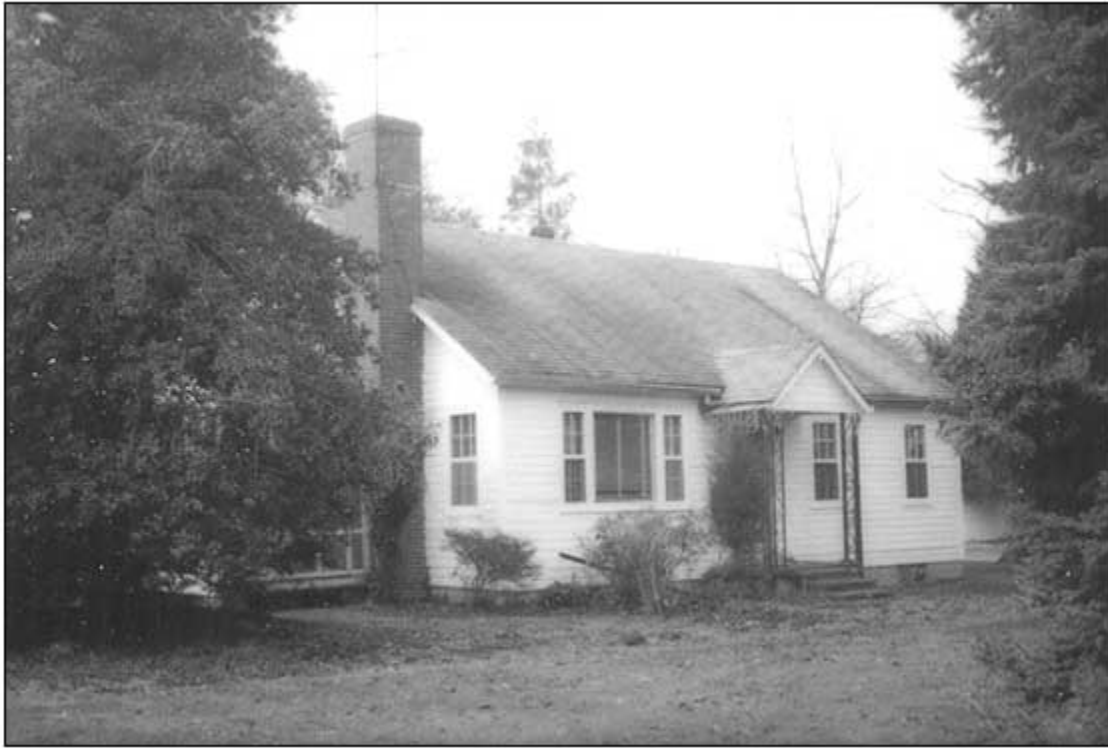
Figures 24 K 7065 429 S Carter

This house is another post-World War II side gable cottage, constructed around 1948 (Figure 24). The dwelling has drop siding, 6/6 wood sash windows, and a concrete block foundation. Features include a large brick chimney on the east façade and a single pane picture window flanked by 4/4 narrow sash windows. The front concrete stoop is covered by a gable roof with open metal supports. A screened side porch with a side-gable roof was added to the east façade soon after construction. A circa-1965 two-car garage faces north on the east side of the house. It has a front-gable roof and vinyl siding.

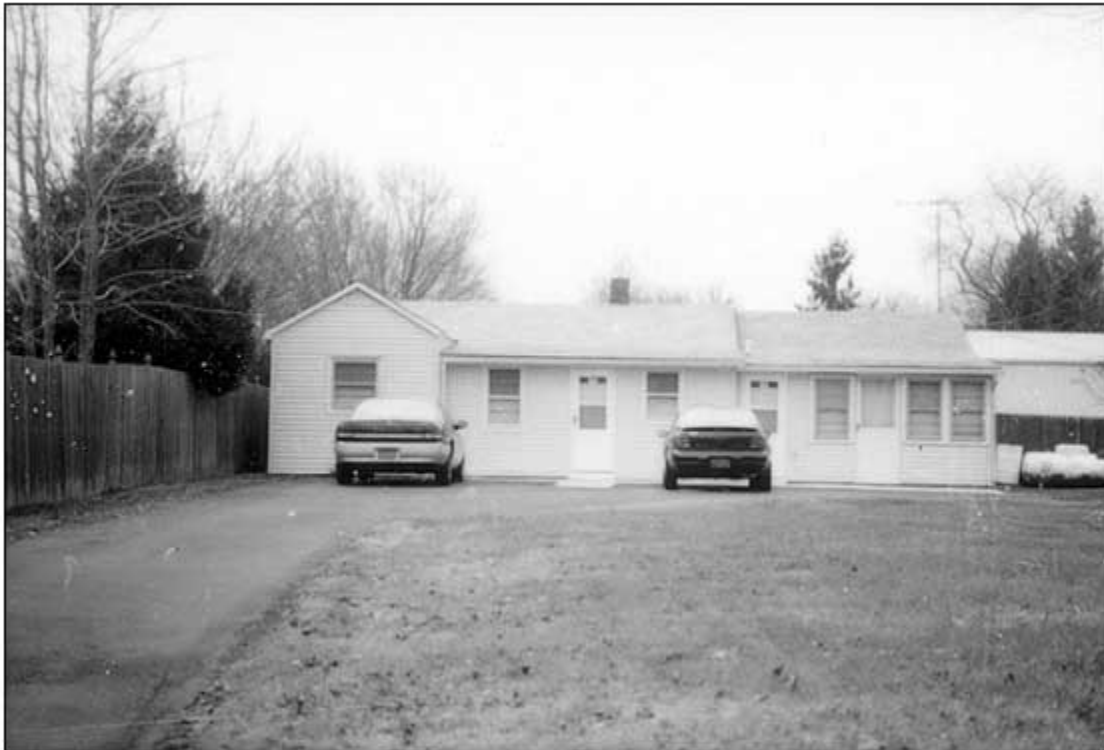
Figure 25 K7067 437 S. Carter

This building is a circa 1945 cottage that has been converted to apartments (Figure 25). It is set back approximately 60 feet from the roadway. The original portion of the building, located on the building's east side, is one story and was built in an L-shape form with an interior brick chimney. It has a concrete foundation, vinyl siding, and composition roof shingles. The main door is located in the center of the side gable portion of the ell with a 2/2 horizontal wood sash window to either side. A circa 1960 side gable addition projects to the west with two doors on the main (north) façade entering into the apartments. Windows and doors are the same type and materials on the addition.

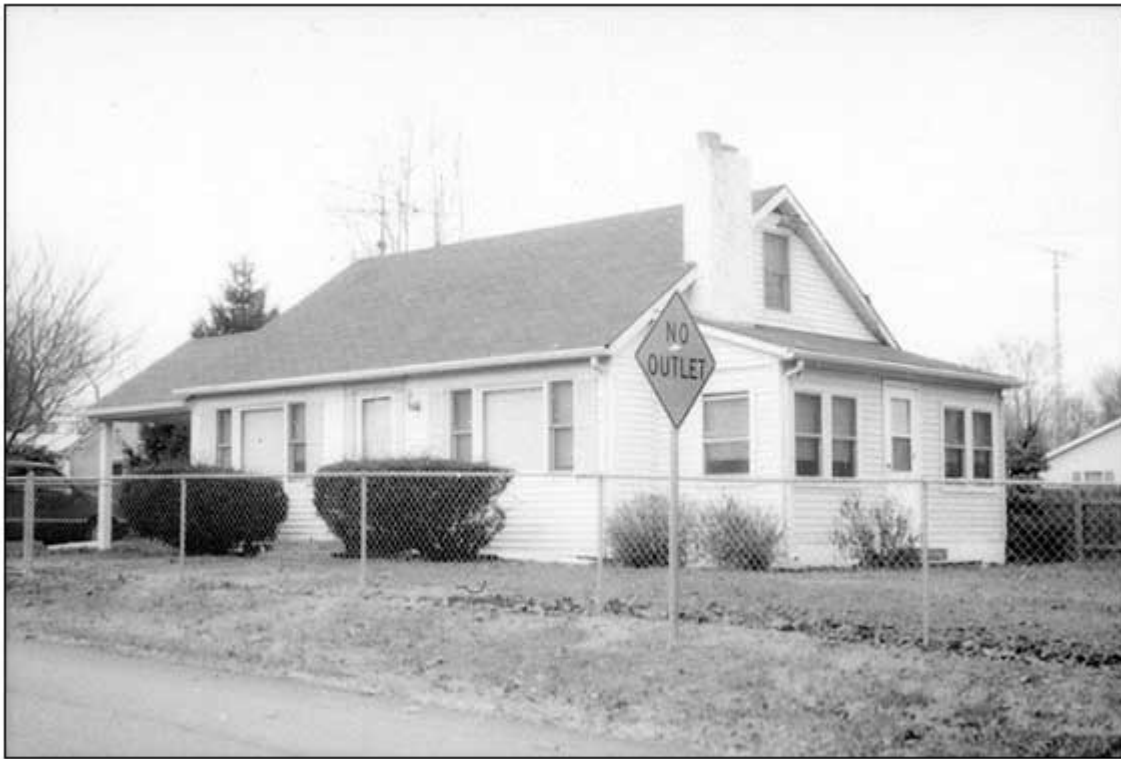
Figures 26 K 7068 16 Manor

This circa 1946, 1½-story cottage faces east at the intersection of Manor Drive and Carter Road (Figure 26). Its side-gable form rests on a concrete block foundation. The siding is vinyl and the windows have been replaced with 1/1 vinyl sashes. The main façade features a central modern door flanked by large picture windows with narrow 1/1 sashes on either side. A large parged brick chimney with an ornamental metal "M" is located along the north façade.

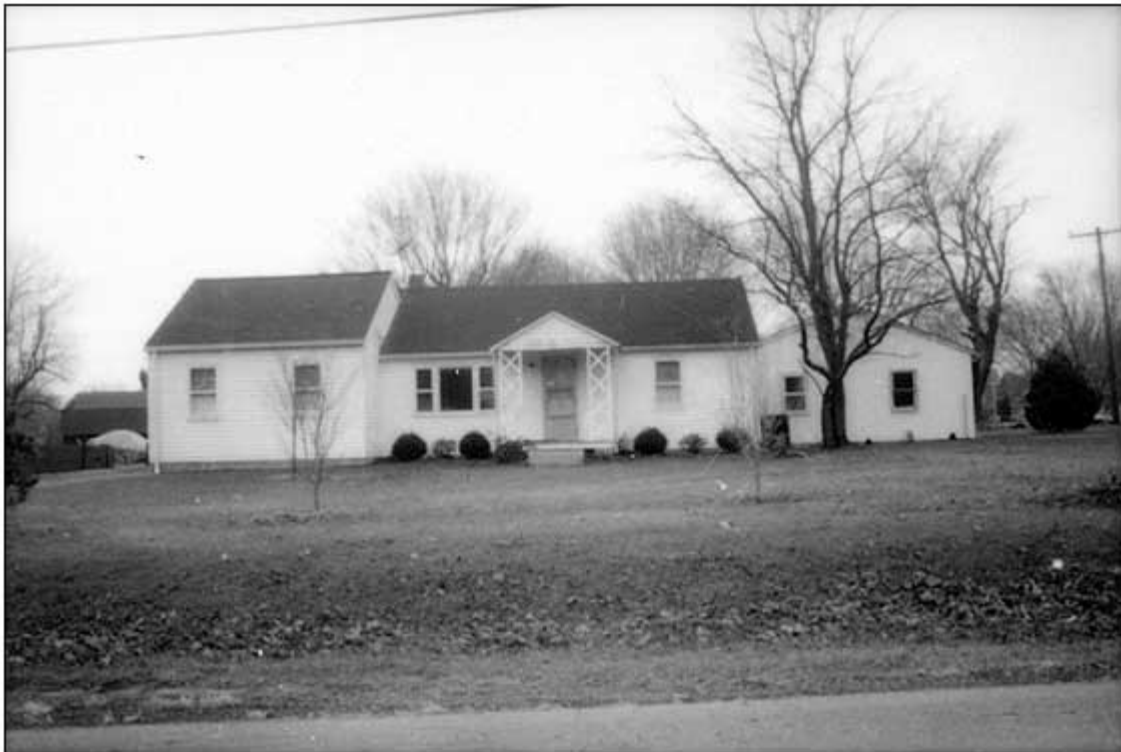
Figure 27 K 7069 509 S. Carter

This small circa 1946 house is a one-story side-gable cottage with a central door under a gable-stoop roof, which is supported by open metal posts (Figure 27). The foundation is concrete

block, the siding is vinyl, and the windows are replacement 1/1 vinyl sashes. A picture window with 1/1 vinyl sidelights decorates the main façade.

A large gable-roof addition was placed on the east side. It projects further northward than the main house and is slightly taller. It rests on a poured concrete foundation and, like the main house, has vinyl siding, 1/1 vinyl sash windows, and a composition shingle roof. A large 2-outbuilding faces west with a metal garage door, plywood siding, and several 1/1 vinyl windows.

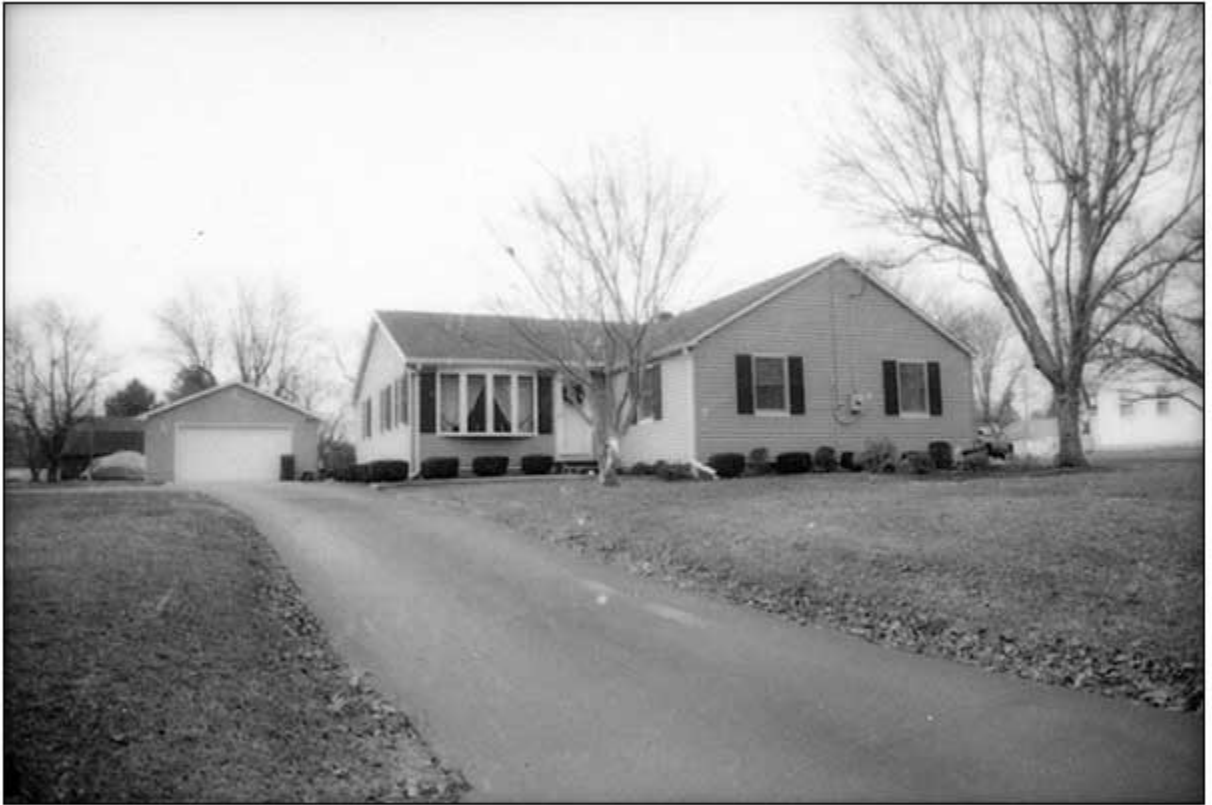
Figure 28 K 7070 515 S. Carter

This circa-1950 dwelling at 515 S. Carter Road is 1½ stories in height and was built in an L-shaped form with a large rear addition (Figure 28). The house rests on a concrete foundation and is sheathed with vinyl siding. Windows are 1/1 wood sashes and a parged chimney projects from the rear of the original house. The modern door is located on the north façade of the side-gable portion of the ell. This façade also contains an added four-pane bay window. The addition has a gable-front form, vinyl siding, and long banks of single-pane vinyl windows along both side facades.
